Documents Related to Elderfields Preserve

Conditions Assessment of Property

FLOWER HILL
ELDERFIELDS, MANHASSET, NY
CONDITIONS ASSESSMENT

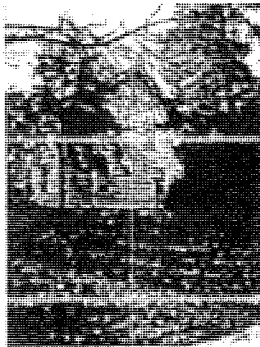
Tree Encroachment. Trees and shrubs planted in close proximity to buildings create moist micro-climates which prevent evaporation from building walls. In wood framed building, this increases the moisture content in structural timbers, making them vulnerable to attack by fungi (i.e., rot) and insects, and hastens the failure of protective paint finishes. Encroaching tree limbs further deposit leaves in gutters and may scour or damage roof and claddings under windy conditions. Recent limbing and clearing of trees and shrubs surrounding the house appear to have opened the house up to better air circulation in general, but there are still three mature trees too close to the house. The holly at the southeast corner of the east wing, a deciduous tree crowding the rear lean-to of the west wing, and a very large conifer at the northeast corner of the west wing, need to be more aggressively limbed or removed.

East wing at east end.

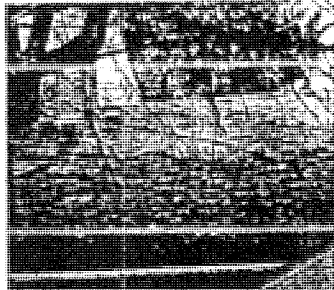
The galvanized step flashings at the chimneys are older than the roof shingles. Recent, minor leaks on the chimney stacks are visible in the east wing attic and second floor of the kitchen wing. Replacement of these flashings with lead-coated copper should be included in the project.

Kitchen wing, south slope at west end.

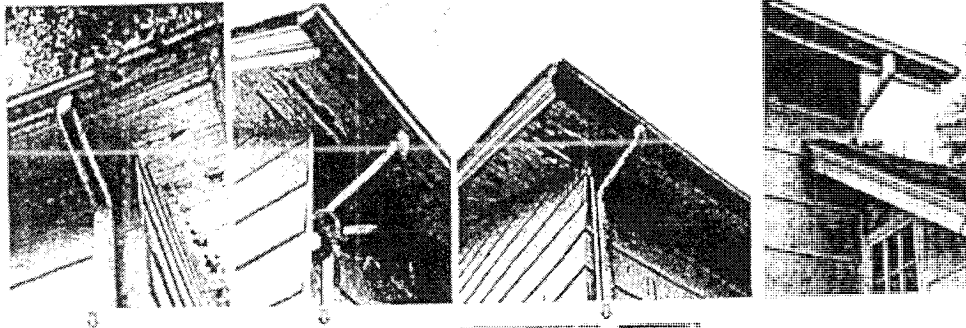
Eaves Trim and Siding. The eaves are plainly trimmed in all sections of the house. The trim is largely intact where visible at raking eaves and soffits, but fascias are likely moisture damaged along gutter runs. The extensive peeling paint at soffits indicates improper roof insulation and/or insufficient air circulation behind. Shingle siding is largely intact, but paint very weathered at the base of the building, where it is subject to backsplash against the perimeter paving below. (For images of typical eaves and siding conditions, see *Perimeter and Roof Drainage* section above.)

East wing, SE corner

The eaves should be repaired as part of the roof project. Insulation should be removed from eaves and reinstalled with plastic air baffles. Linear soffit vents should be introduced behind the fascias into the eaves of the main gable roofs.

The shingles should be scraped, washed with and thoroughly rinsed of biocide and detergent (such as phosphate-free TSP or Mex® or equivalents), primed, and repainted with two coats of finish paint following replacement of rotted shingles at the base.

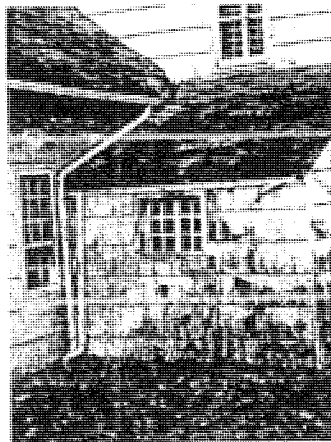
Kitchen wing, SE corner

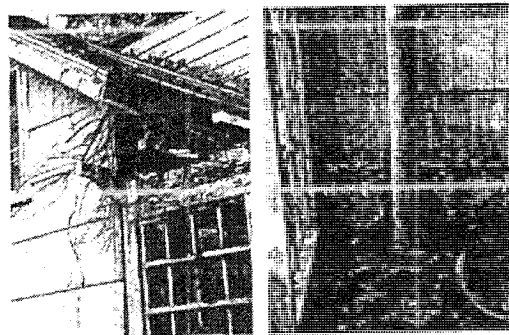
The roof drainage system, consisting of gutters, downspouts, and above- and below-grade disposition points, is in poor working condition. It is not original to the house, and includes at least three generations of hardware. All eaves of the main roof are or were recently equipped with built-in wood troughs or attached metal box gutters. The gutters drain to eleven downspouts. The wood gutters are rotted, and one box gutter is missing. The gutters were filled with leaves. Eight downspouts dispose water below grade; disposition points are not known. Two drain above grade close to the rear foundation, and another is missing.

Kitchen wing, gutter (L) and leader boot (R) at NE corner

The gutters and downspouts should be replaced as part of the planned re-roofing project. Below grade disposition points should be located, mapped, tested, and if necessary, re-routed. In the short term, gutters and downspouts should be cleaned, and above-ground drainage should be

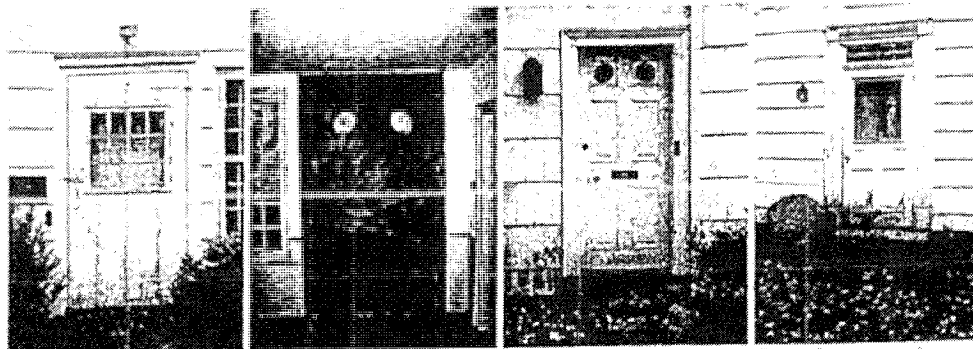
All storm doors are loose and need major repair. At a minimum, joints need tightening, glass needs reputting, and woodwork needs scraping and painting. Two storm units, and one 20th century prime door, are moisture damaged at their lower rails. Hardware on all doors needs to be adjusted. Wrought and cast iron hardware, which is important to the historic character of the house, is not suitable to public use. It should be retained and augmented with contemporary hardware in working entrances and emergency exits.

Front door, east wing.

Front door, west wing.

Front door, kitchen wing.

For public use, the principal public entrance will need to be ramped and refurbished for barrier-free access, and another doorway should be designated for use as the service entrance for major deliveries, trash removal, etc. The front doorway of the east wing is the widest opening and would be the most appropriate for the barrier free entrance. The historic door unit should be treated with care in the process. The second widest entrance, at the rear of the kitchen wing, would be suitable for the service entrance.

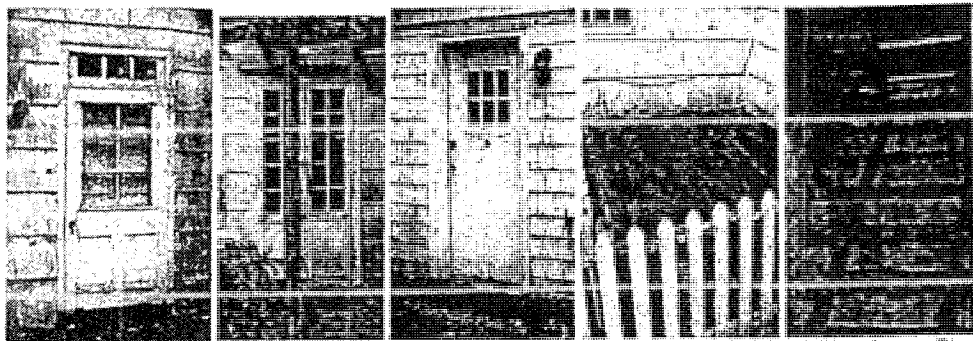
Rear door, east wing.

Rear door, kitchen.

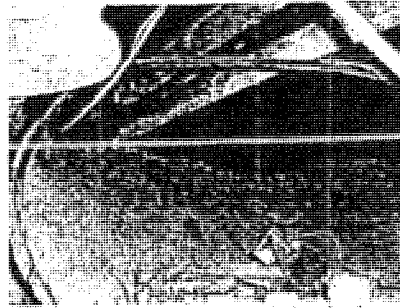
The service drop for the main house is on the east elevation. The conduit service, which probably dates from when central air conditioning was installed, is equipped for 400 amps at the meter. Circuits within the house are wired for minimal residential loads from an early 20th century cartridge fusebox. The fusebox also feeds a late 20th century 105 amps circuit breaker sub-panel. 90 amps of this panel are dedicated to the air conditioning condenser and blower

Typical wiring in crawl space below kitchen wing.

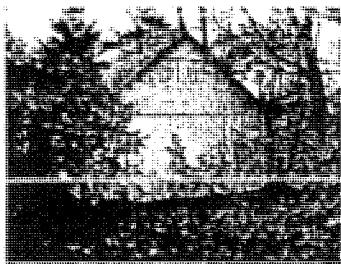
Tree and Vine Encroachment. Trees, shrubs and vines are too close to three of the outbuildings. Vines should be removed from the walls of these buildings. All low shrubs should be cleared within 10 feet of the foundations. All trees and large shrubs should be limbed within 15 feet of the buildings.

Garage 1 at rear (south).

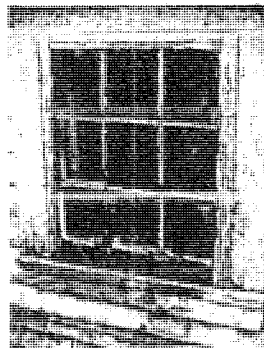
Sash. The fixed sash on the unheated outbuildings are in need of general maintenance. The sash is presently marginally watertight except for the north sash of the potting shed, which needs major repair. The sash on the studio cottage appears to be in satisfactory weathertight condition.

Potting Shed, north window.
