Documents Related to Elderfields Preserve

Conditions Assessment of Property

FLOWER HILL
ELDERFIELDS, MANHASSET, NY
CONDITIONS ASSESSMENT

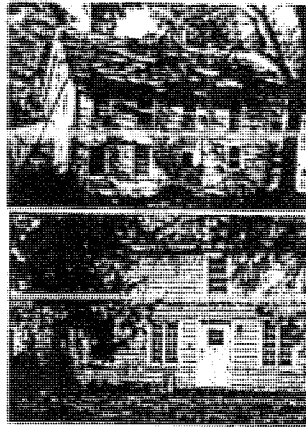
The stage V west wing, view of front toward the northeast

The stage V west wing, partial view toward the south of rear elevation.

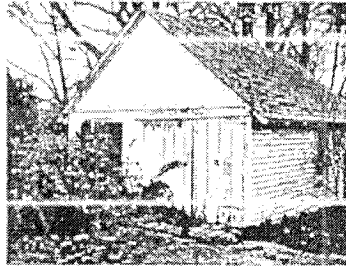
Garage 1 is a small gable-roofed one-car garage. The building dates from the early 20th century based on its light framing, exposed rafter tails and drive-through garage bay. The building is built on a slab, sided with clapboard and vertical board siding, and is roofed with asphalt shingles.

Garage 1, view toward the southeast.

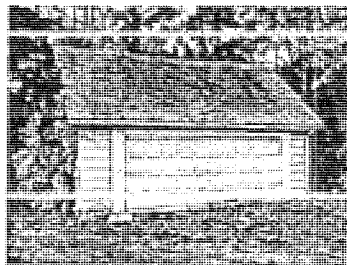
Garage 2 is a two-car gable-roofed garage built on a slab. The building appears to date from the mid- to late 20th century. It is sided with clapboard and roofed with asphalt shingles.

Garage 2, view of front toward the southwest.

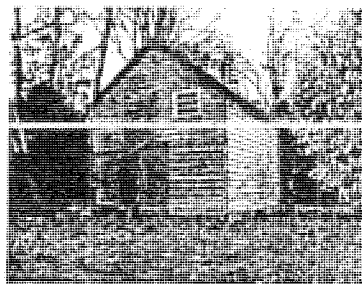
The **Carriage Barn** is a two-story gable-roofed structure which appears to be built on a low footing and date from the mid- to late 19th century. It is sided with clapboard and roofed with asphalt shingles.

Carriage Barn, view of front toward the northwest.

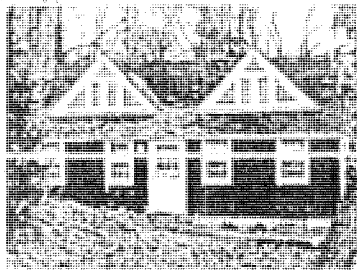
The Studio Cottage is a one-and-one-half story, shingle-clad gable-roofed structure. Situated on a patio terrace, it appears to be built and date from the early- to mid- 20th century.

Studio Cottage, view of front toward the north

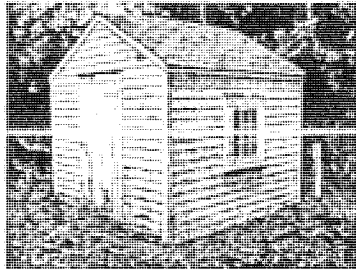
The Potting Shed is a small one-story, clapboard outbuilding that appears to date from the early- to mid- 20th century.
